# Failure Analysis of the Arecibo Observatory 305-Meter Telescope Collapse (2024)

# Failure Analysis of the Arecibo Observatory 305–Meter Telescope Collapse

Committee on Analysis of Causes of Failure and Collapse of the 305–Meter Telescope at the Arecibo Observatory

Consensus Study Report

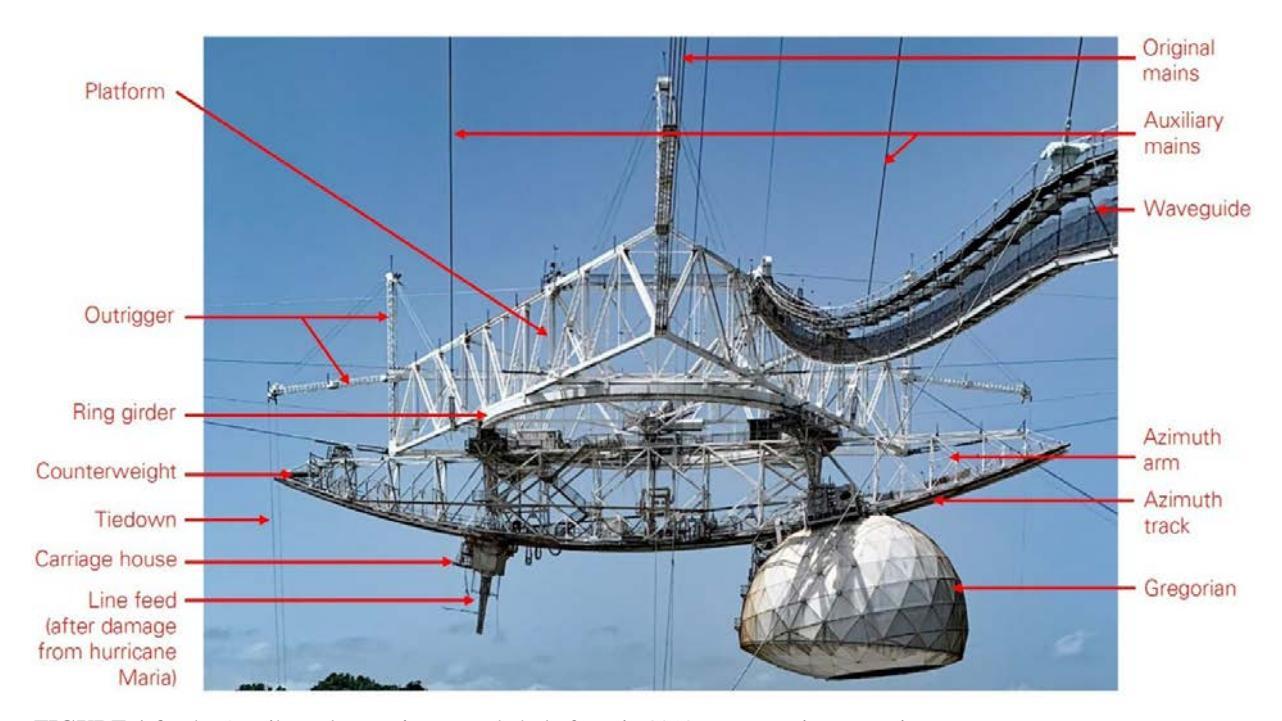
**FIGURE 1-3** The Arecibo Telescope's suspended platform in 2019, post-Hurricane Maria. SOURCE: Thornton Tomasetti, 2022, *Arecibo Telescope Collapse: Forensic Investigation*, NN20209, prepared by J. Abruzzo, L. Cao, and P.E. Pierre Ghisbain, July 25, https://www.thorntontomasetti.com/sites/default/files/2022-08/TT-Arecibo-Forensic-Investigation-Report.pdf; modified from photo by Mario Roberto Durán Ortiz, Wikipedia, CC BY-SA 4.0; courtesy of Thornton Tomasetti.

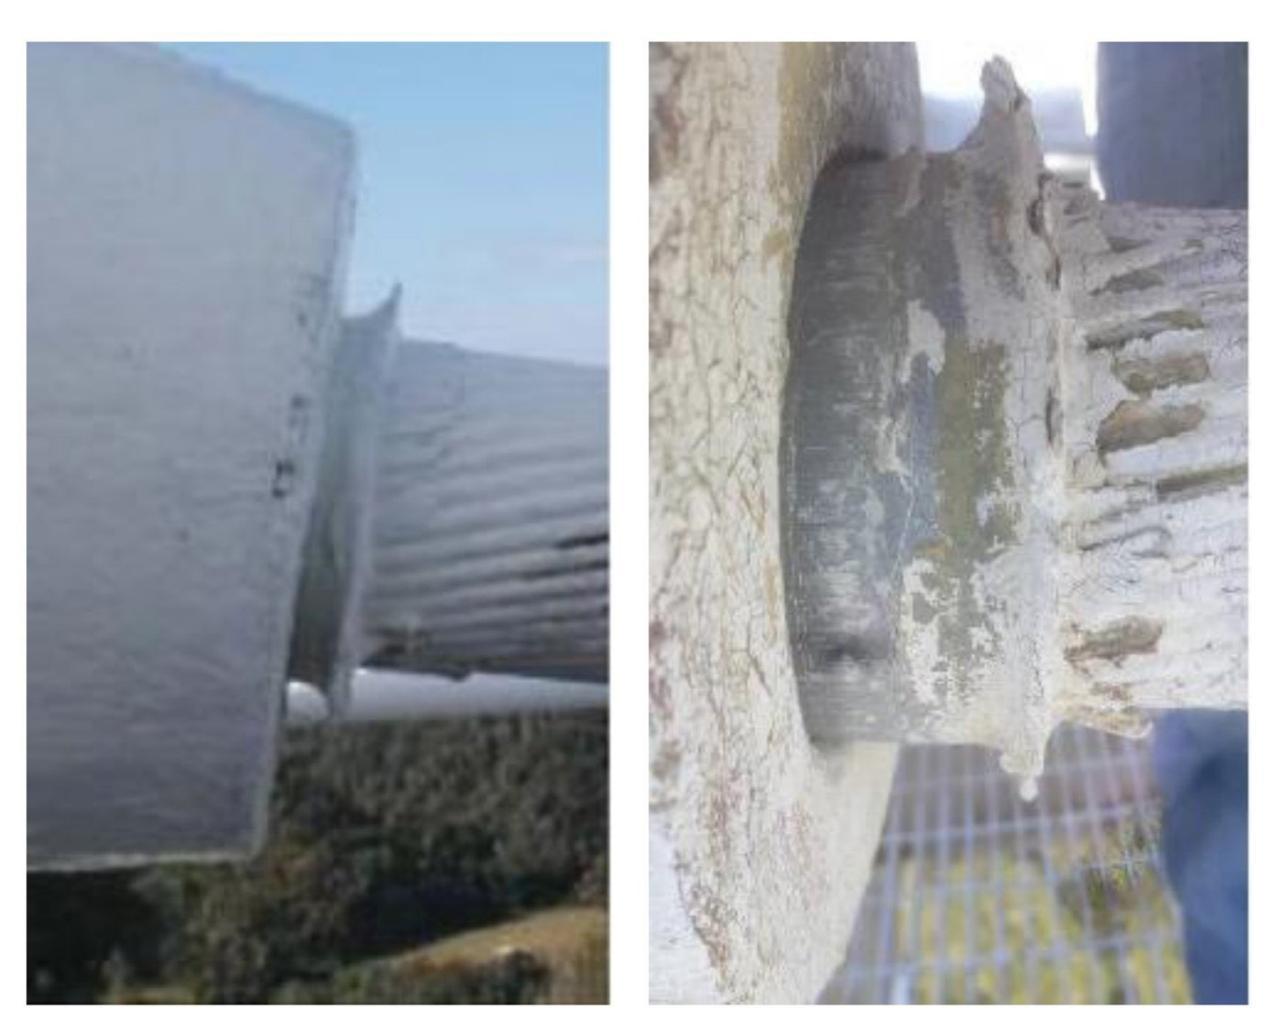
FIGURE 2-3 Zinc pullout of auxiliary socket M4S-T in 2003 (left) and M4N-T in 2019 post-Maria (right). SOURCES: G.J. Harrigan, A. Valinia, N. Trepal, P. Babuska, and V. Goyal, 2021, *Arecibo Observatory Auxiliary M4N Socket Termination Failure Investigation*, NASA/TM–20210017934, NESC-RP-20-01585, NASA Engineering and Safety Center, Langley Research Center, June 15, https://ntrs.nasa.gov/api/citations/20210017934/downloads/20210017934%20FINAL.pdf, Figure 6.4-2. *Left:* Photo from Ammann & Whitney, NAIC Cornell University, Arecibo Radio Telescope, Structural Condition Survey 2003, courtesy of Division of Rare and Manuscript Collections, Cornell University Library. *Right:* Photo from NAIC Arecibo Observatory, a facility of the National Science Foundation.

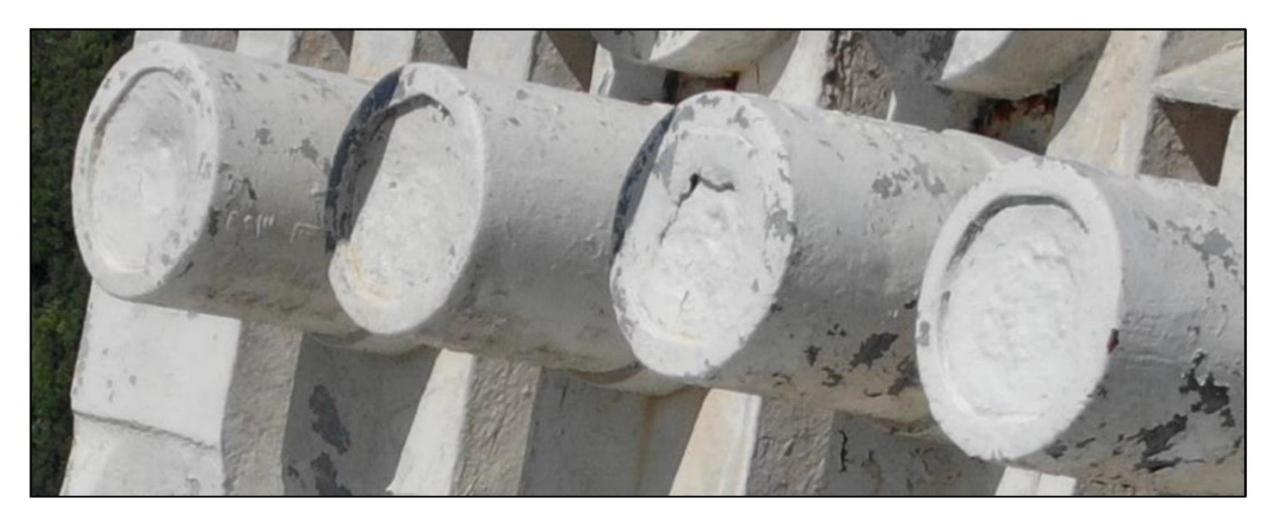
**FIGURE 2-4** Socket depressions on the M4 tower end. SOURCE: Thornton Tomasetti, 2021, *Arecibo Telescope Collapse: Forensic Investigation Interim Report*, NN20209, prepared by J. Abruzzo and L. Cao, November 2; photo from NAIC Arecibo Observatory, a facility of the National Science Foundation.

after Hurricane Maria.<sup>33</sup> The last known cable slip documentation of socket M4N-T of (1.125 inches), where the first cable failure occurred, was observed on February 19, 2019,<sup>34</sup> more than 18 months after the hurricane but still more than 18 months before the failure. The observed slip of M4N-T was now at least one-third of the cable's diameter in 2019. "The inspection process did not couple the qualification/design process to a pass/fail criterion to trigger a replacement. Data were not provided to explain the decision process after the 2019 photos were taken."<sup>35</sup> The committee concurs with both these conclusions.

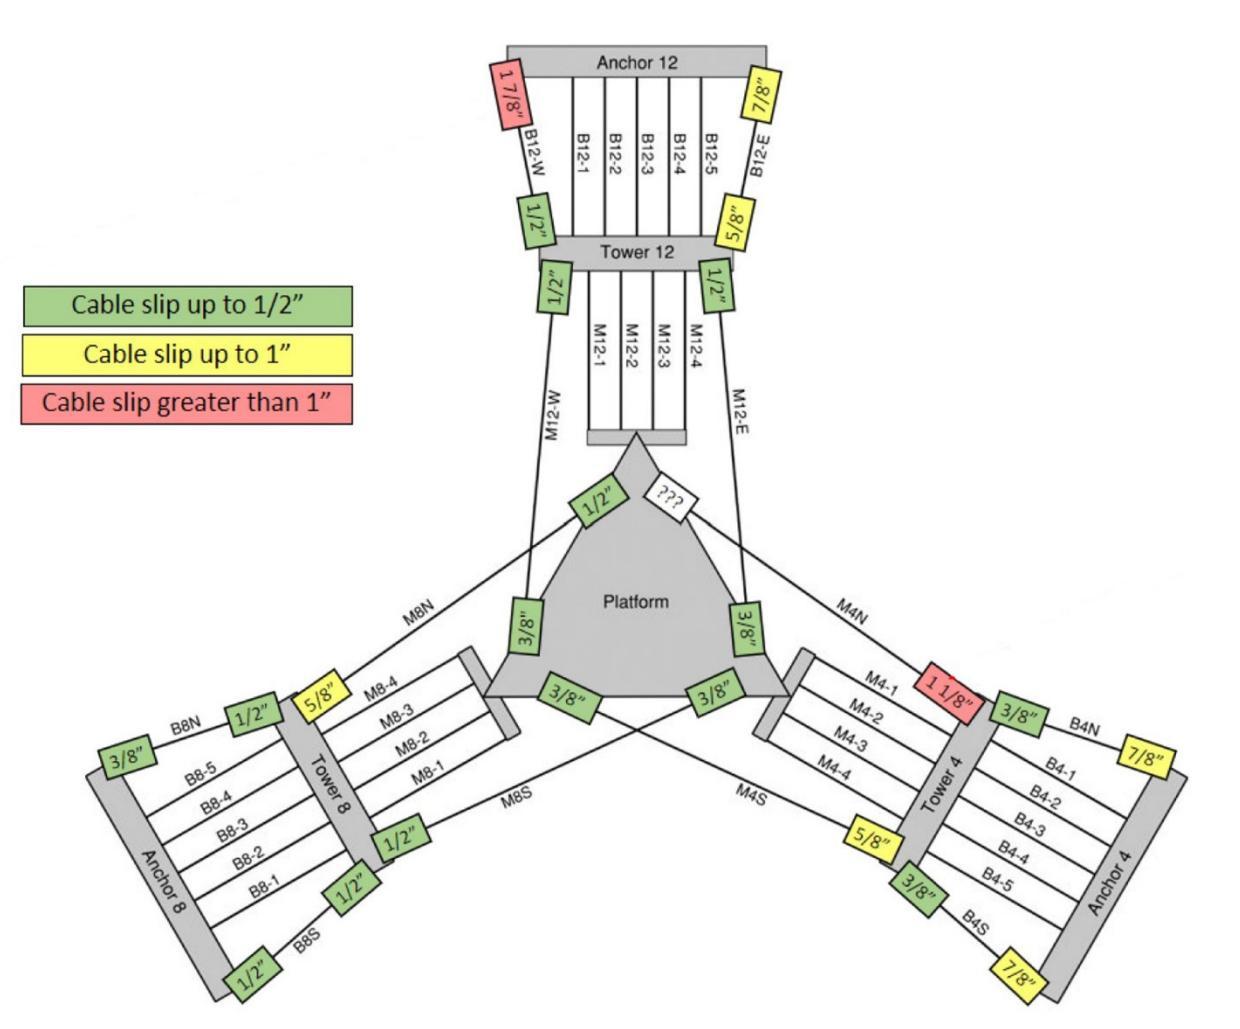
**FIGURE 2-5** Arecibo Telescope socket pullout (slip), post-Maria, before the M4N-T socket failure. SOURCE: J. Abruzzo, L. Cao, and P. Ghisbain, 2022, "Arecibo Observatory: Stabilization Efforts and Forensic Investigation," Thornton Tomassetti, Inc., presentation to the committee, February 17, slide 28; courtesy of Thornton Tomassetti, Inc.

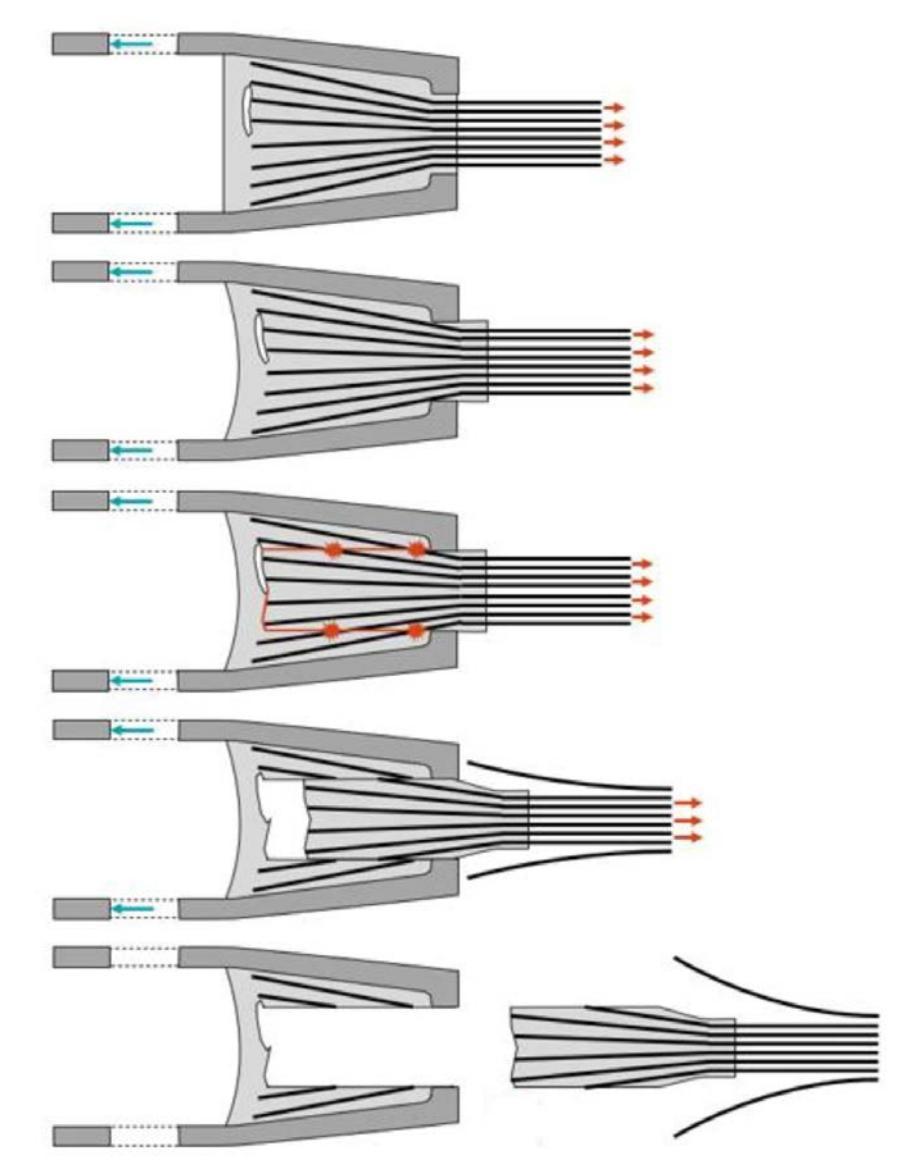
**FIGURE 2-6** Schematic of wire broom geometry and failure sequence of socket M4N-T. SOURCE: Thornton Tomasetti, 2022, *Arecibo Telescope Collapse: Forensic Investigation*, NN20209, prepared by J. Abruzzo, L. Cao, and P.E. Pierre Ghisbain, July 25, https://www.thorntontomasetti.com/sites/default/files/2022-08/TT-Arecibo-Forensic-Investigation-Report.pdf; courtesy of Thornton Tomasetti.

kips, giving it a safety factor of 2.2.<sup>81</sup> M4N-T's unanticipated failure illustrated that the safety factor calculated for the socket was inaccurate.

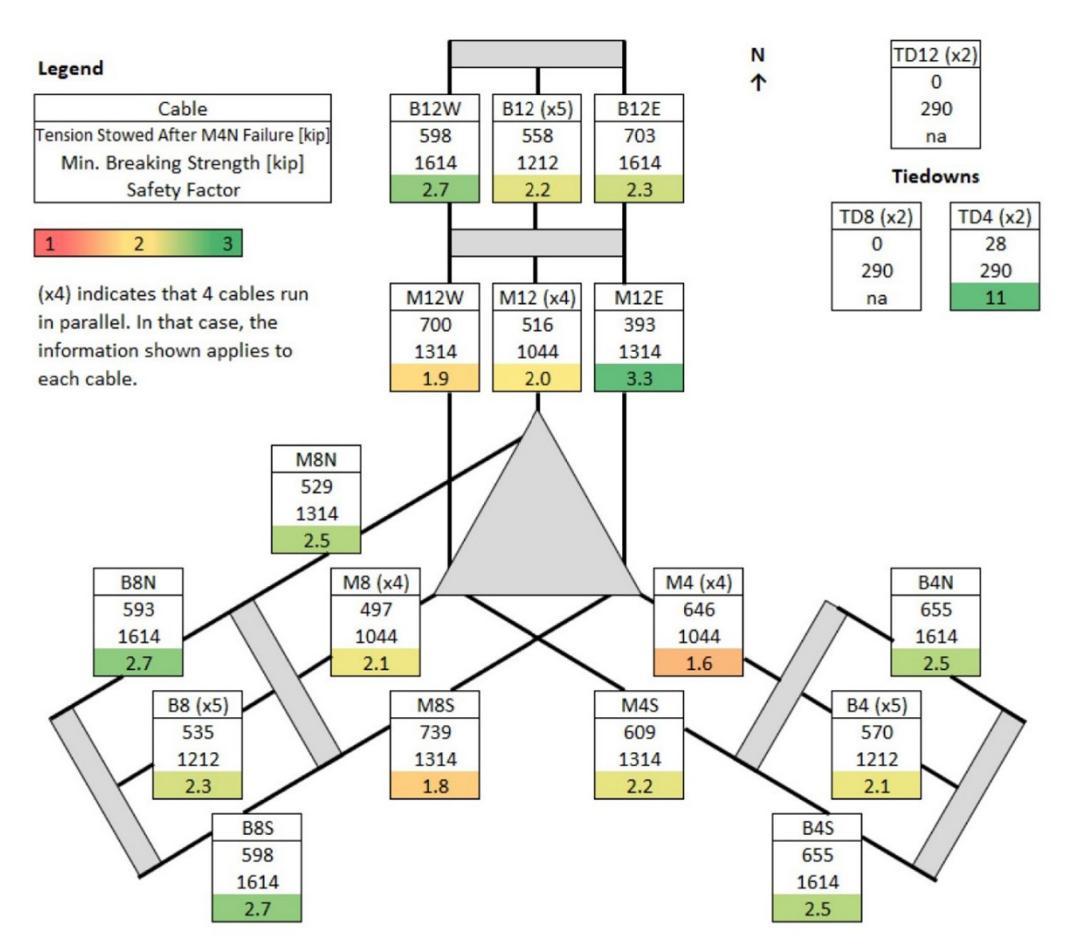
**FIGURE 2-7** The TT calculated "Safety Factor" sockets post the M4N-T failure. SOURCE: Thornton Tomasetti, 2022, *Arecibo Telescope Collapse: Forensic Investigation*, NN20209, prepared by J. Abruzzo, L. Cao, and P.E. Pierre Ghisbain, July 25, https://www.thorntontomasetti.com/sites/default/files/2022-08/TT-Arecibo-Forensic-Investigation-Report.pdf; courtesy of Thornton Tomasetti.

After the M4N-T failure, the main cables to Tower 4, M4 (×4) became loaded to 646 kips (the highest service load they had ever borne in 57 years)<sup>84</sup> compared to 516 kips in the M12 (×4) mains and 497 kips in the M8 (×4) mains, as illustrated in Figure 2-7. This reduced the TT computed (but incorrect) safety factor to 1.6, even with the telescope stowed because of the increased load.<sup>85</sup> However, the safety factor was actually near 1.0 because of a decreased cable strength at this load. This decrease in cable strength was due to hidden outer wire failures, which had already fractured due to shear stress from zinc pullout.

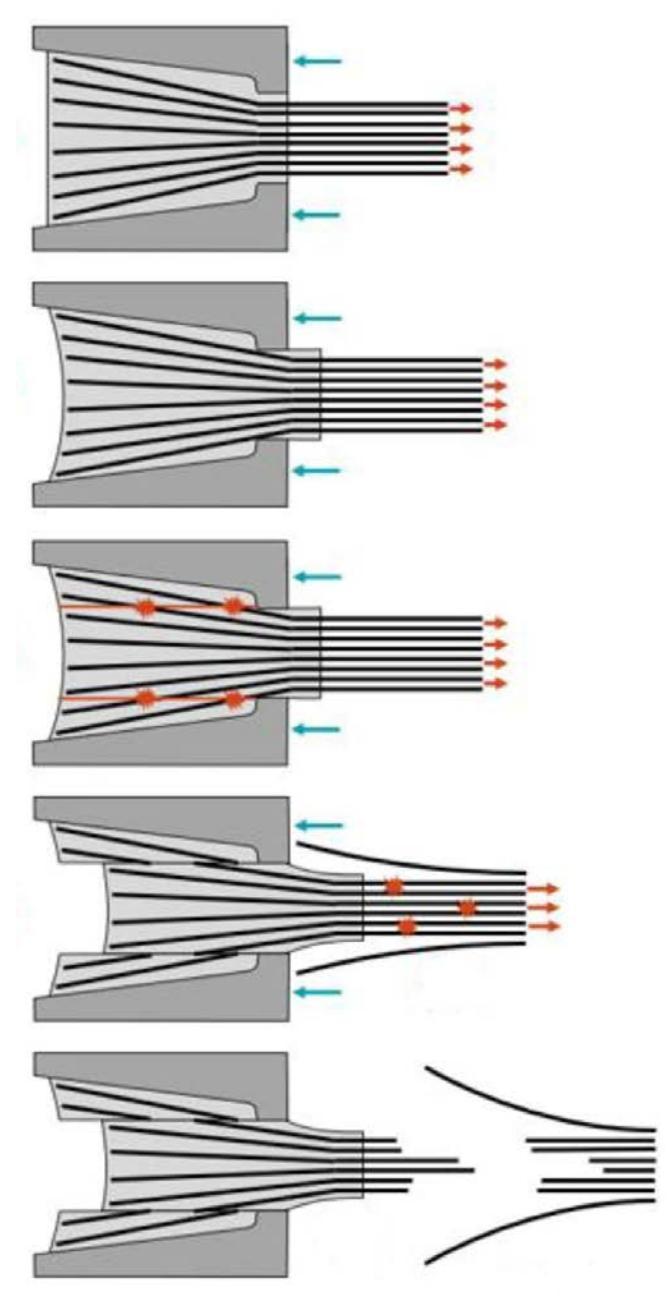
FIGURE 2-8 Failure sequence of socket M4-4T.

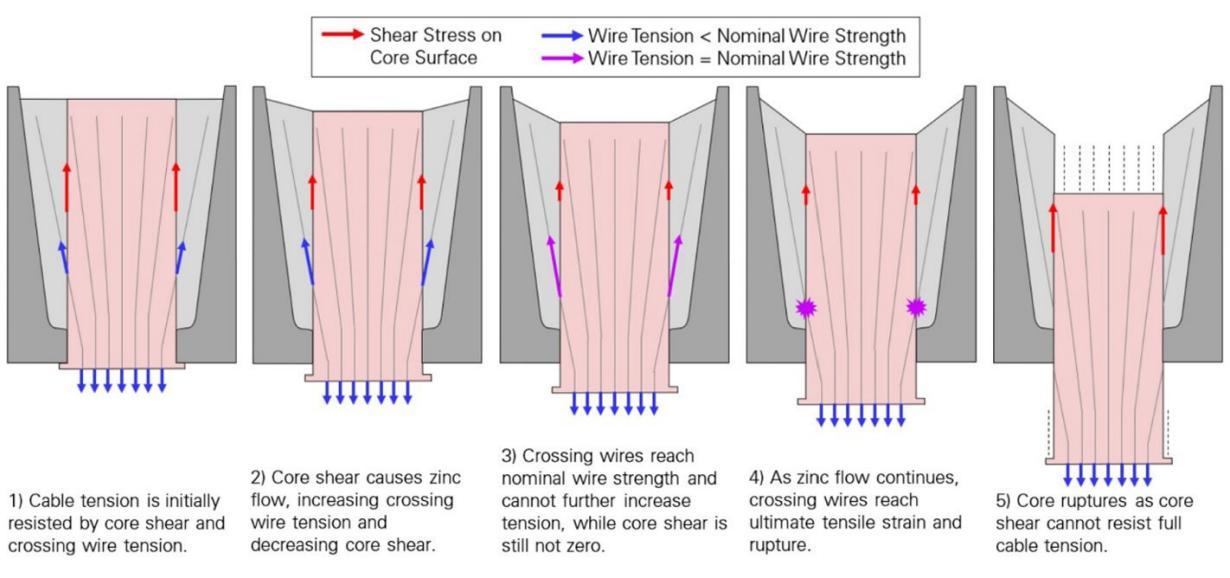
**FIGURE 3-1** Core rupture when crossing wires cannot resist full cable tension and are fully developed. SOURCE: Thornton Tomasetti, 2022, *Arecibo Telescope Collapse: Forensic Investigation*, NN20209, prepared by J. Abruzzo, L. Cao, and P.E. Pierre Ghisbain, July 25, https://www.thorntontomasetti.com/sites/default/files/2022-08/TT-Arecibo-Forensic-Investigation-Report.pdf; courtesy of Thornton Tomasetti.

Based on the observed Arecibo Telescope socket slip and the results of laboratory testing, it appears that all cable pullouts greater than  $\frac{1}{2}$  inch may involve zinc creep.

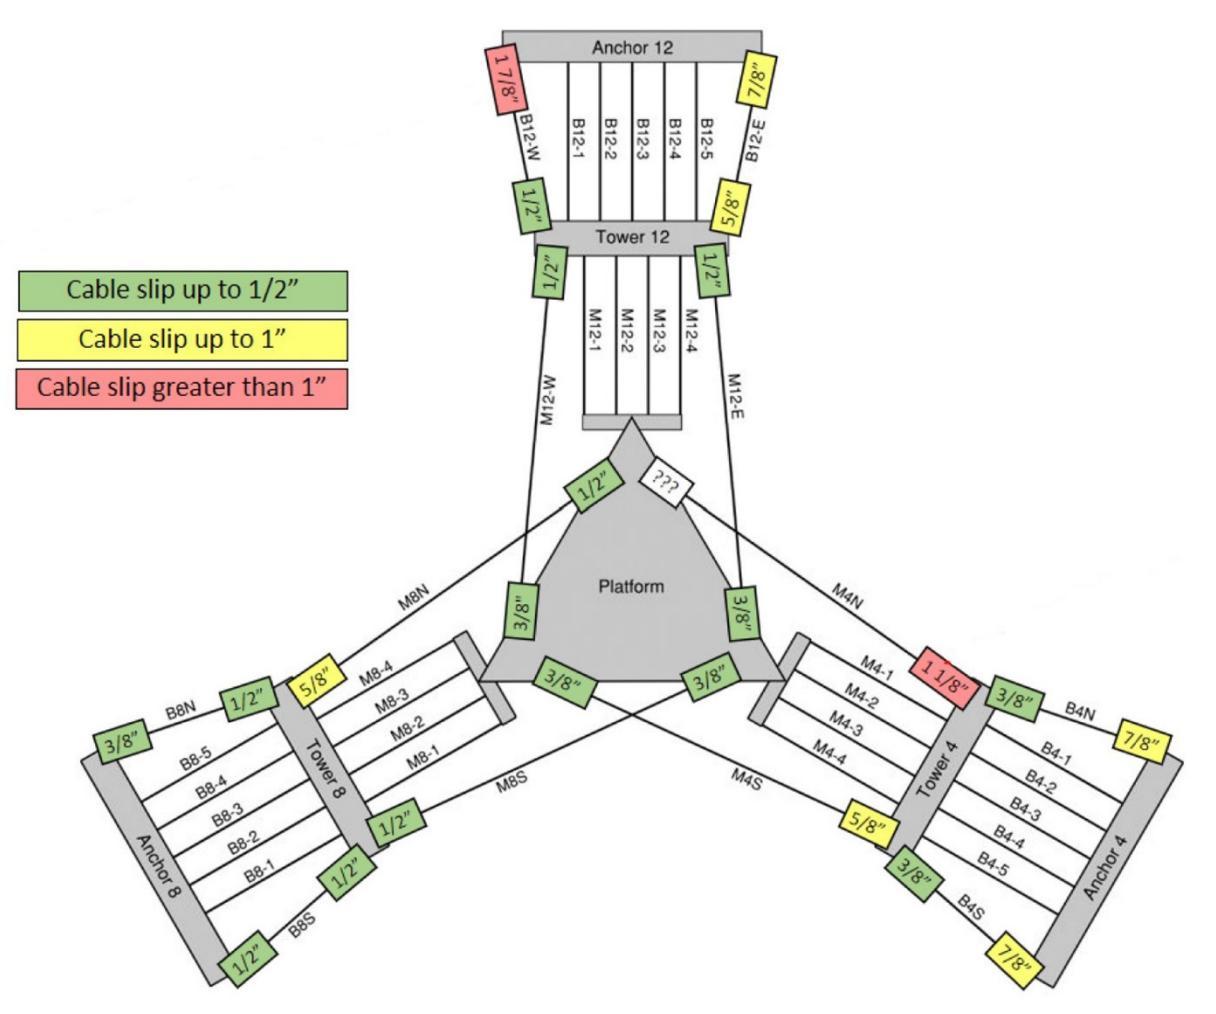
**FIGURE 3-6** Post-Maria auxiliary main cable socket pullout before M4N-T failure. SOURCE: J. Abruzzo, L. Cao, and P. Ghisbain, 2022, "Arecibo Observatory: Stabilization Efforts and Forensic Investigation," Thornton Tomassetti, Inc., presentation to the committee, February 17, slide 28; courtesy of Thornton Tomassetti, Inc.

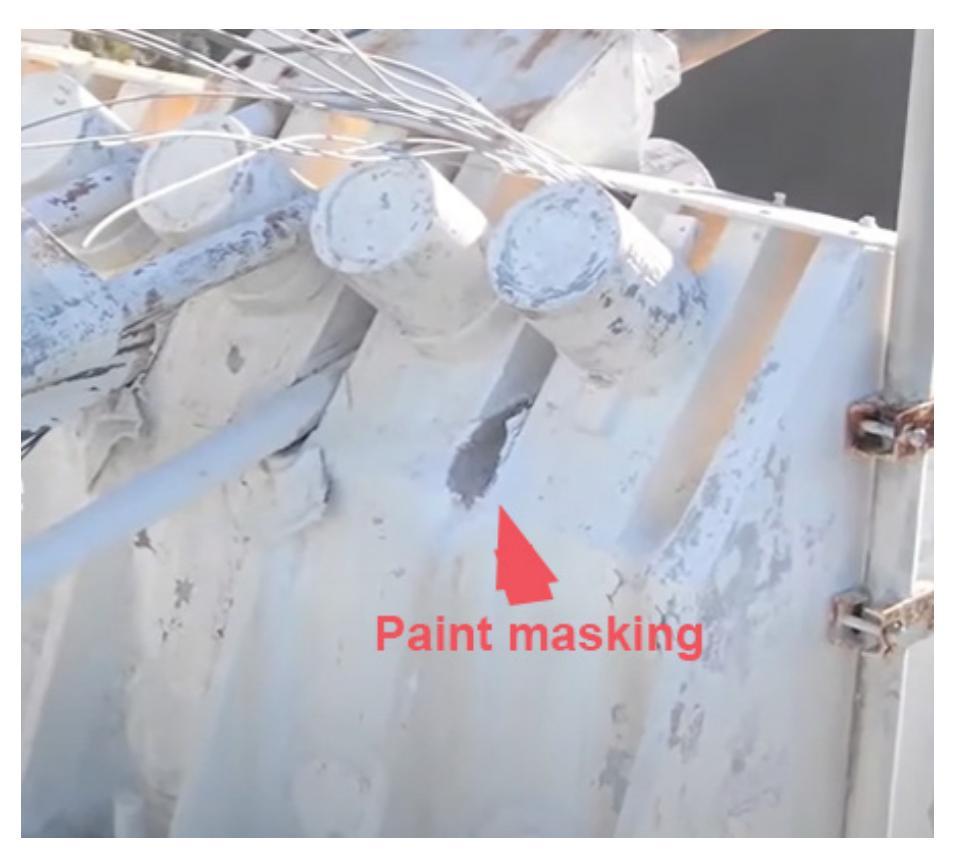
FIGURE 3-7 Drone picture of Tower 4 Saddle after cable M4-4 failure.

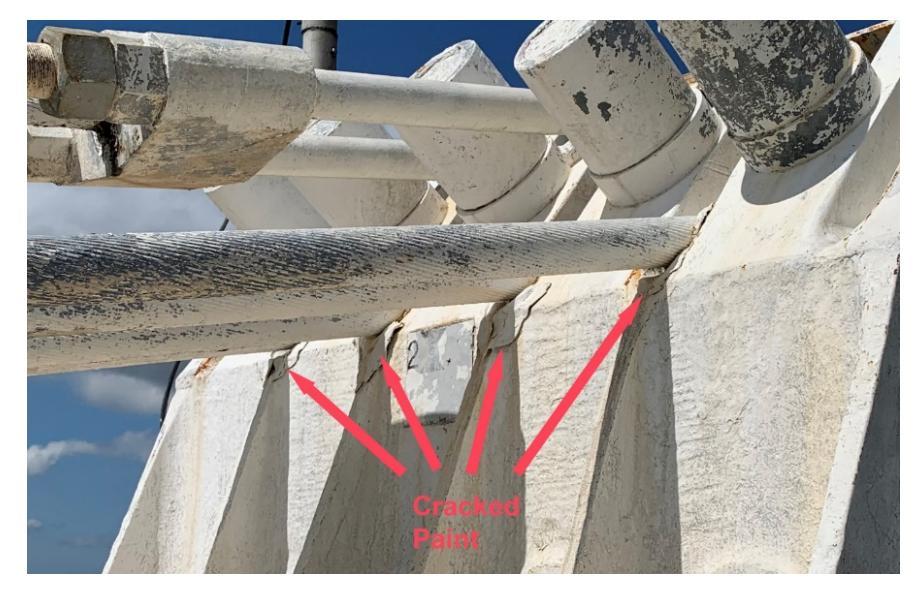
**FIGURE 3-8** Closeup of IMG\_2173, cracked paint below all four main cable saddle slots on Tower 12. SOURCE: Photo IMG\_2173 from January 27, 2020, inspection of Tower 12 provided to staff, with labels added by the committee; courtesy of NAIC Arecibo Observatory, a facility of the National Science Foundation.

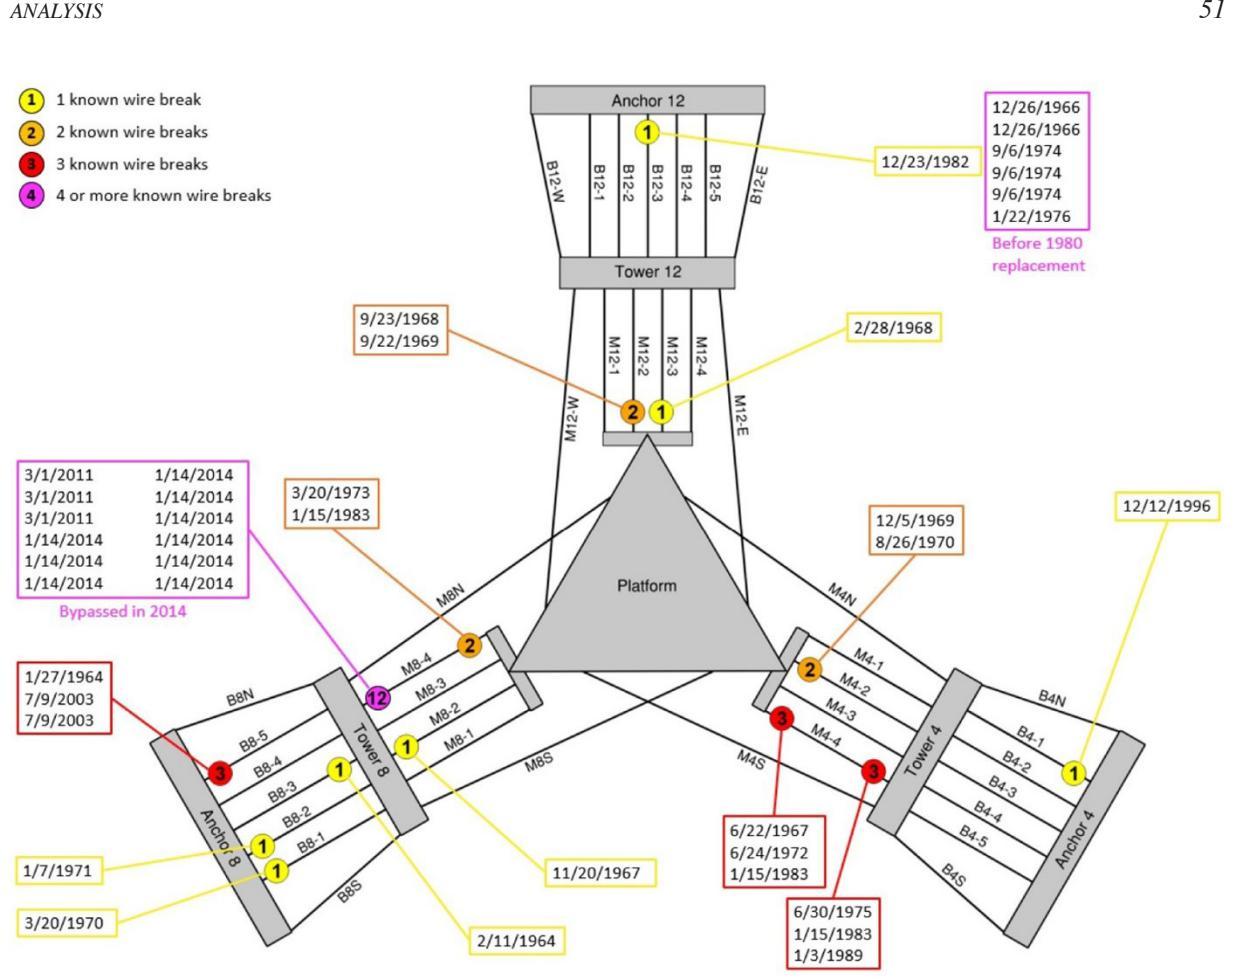
FIGURE 3-10 Known wire break locations and discovery dates before the first cable failure. SOURCE: Thornton Tomasetti, 2022, Arecibo Telescope Collapse: Forensic Investigation, NN20209, prepared by J. Abruzzo, L. Cao, and P.E. Pierre Ghisbain, July 25, https://www.thorntontomasetti.com/sites/default/files/2022-08/TT-Arecibo-Forensic-Investigation-Report.pdf; courtesy of Thornton Tomasetti.

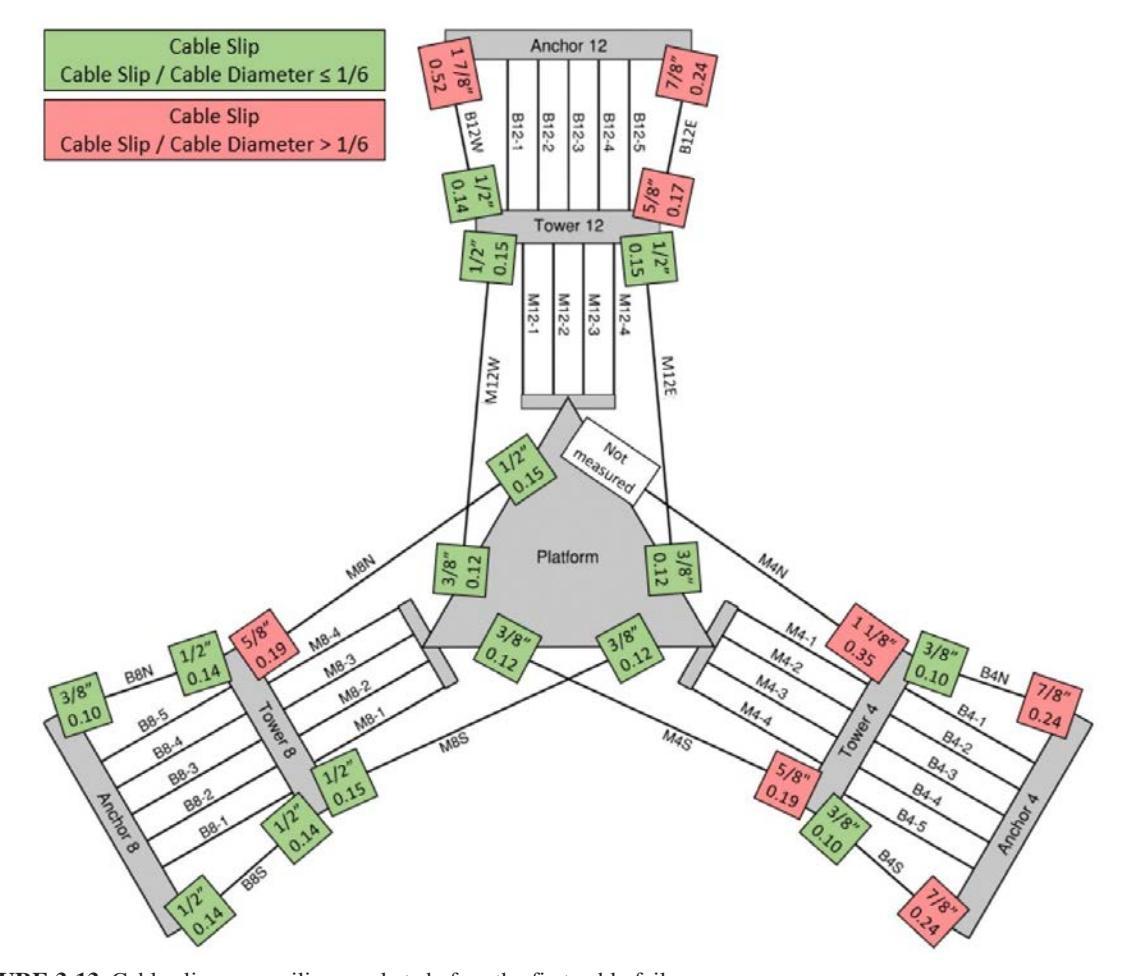
**FIGURE 3-13** Cable slips on auxiliary sockets before the first cable failure. SOURCE: Thornton Tomasetti, 2022, *Arecibo Telescope Collapse: Forensic Investigation*, NN20209, prepared by J. Abruzzo, L. Cao, and P.E. Pierre Ghisbain, July 25, https://www.thorntontomasetti.com/sites/default/files/2022-08/TT-Arecibo-Forensic-Investigation-Report.pdf; courtesy of Thornton Tomasetti.

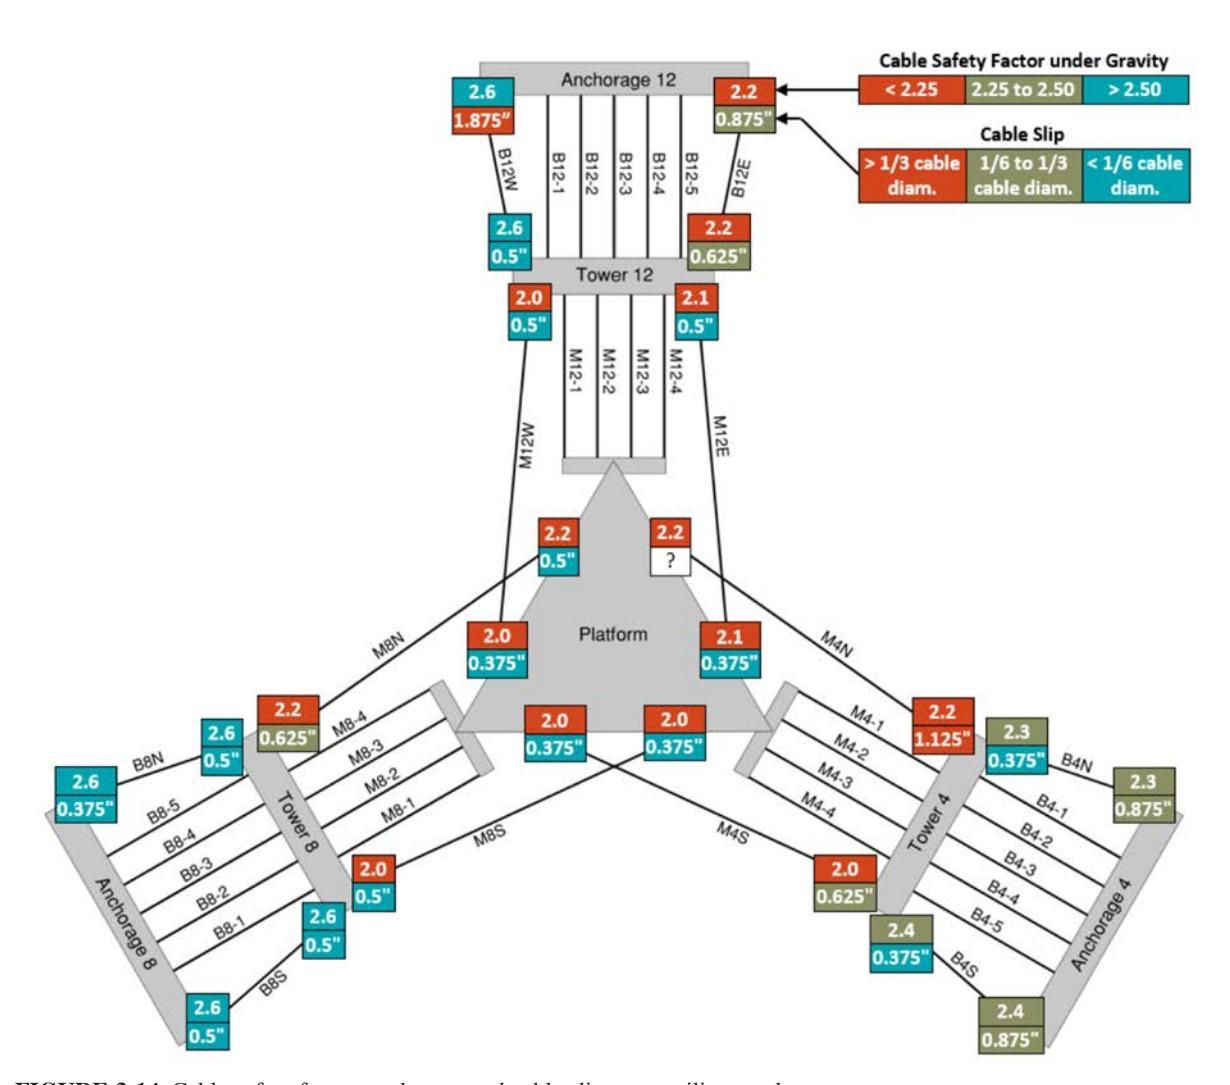
**FIGURE 3-14** Cable safety factors and measured cable slips on auxiliary sockets. SOURCE: Thornton Tomasetti, 2022, *Arecibo Telescope Collapse: Forensic Investigation*, NN20209, prepared by J. Abruzzo, L. Cao, and P.E. Pierre Ghisbain, July 25, https://www.thorntontomasetti.com/sites/default/files/2022-08/TT-Arecibo-Forensic-Investigation-Report.pdf; courtesy of Thornton Tomasetti.

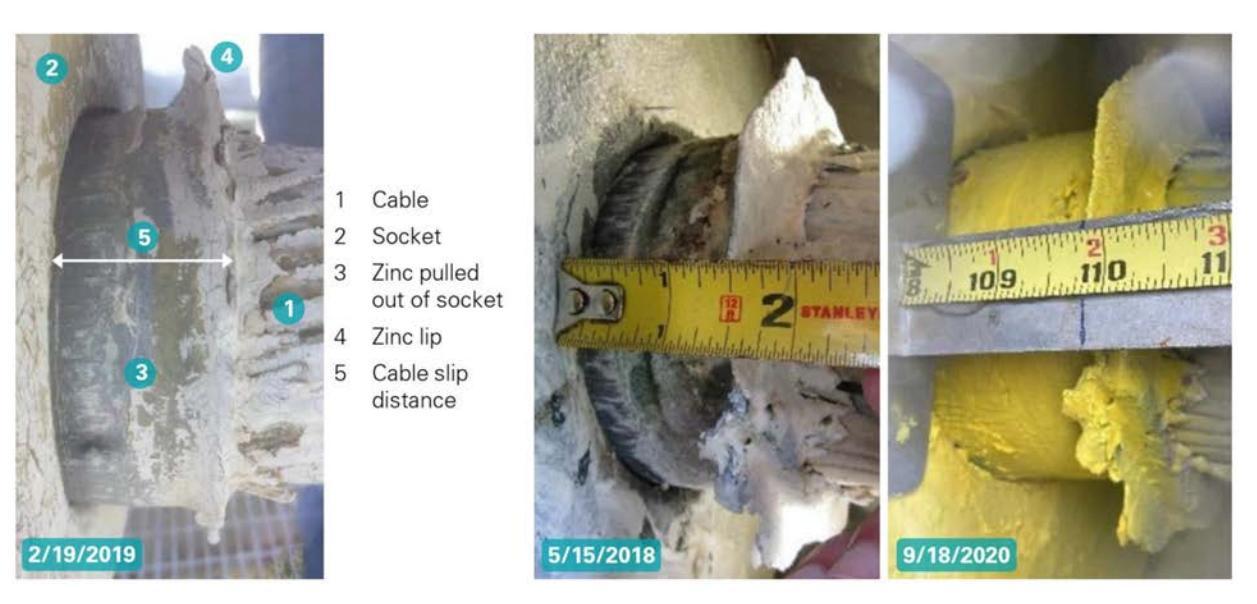
#### FIGURE 3-15 Images showing physical measurement of cable socket slippage.
