# Failure Analysis of the Arecibo Observatory 305-Meter Telescope Collapse (2024)

# Failure Analysis of the Arecibo Observatory 305–Meter Telescope Collapse

Committee on Analysis of Causes of Failure and Collapse of the 305–Meter Telescope at the Arecibo Observatory

Consensus Study Report

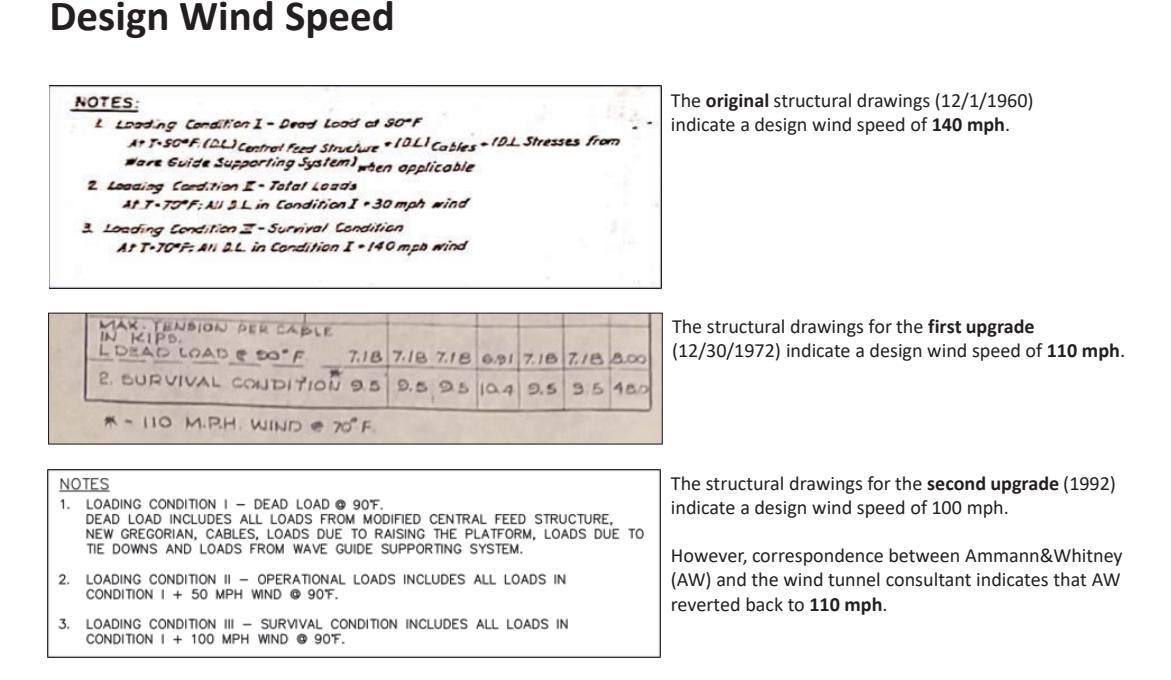
The maximum wind speed the Arecibo Telescope was designed to withstand, and with what factor of safety, is unclear from the records and has changed with upgrades. The National Aeronautics and Space Administration (NASA) observed, "It is worth reflecting on the original design that considered the "survival" condition to be 100 mph winds."<sup>13</sup> After the Gregorian dome upgrades, the "survival loading" condition included wind effects from 100 mph winds.<sup>14</sup> However, TT reported, "The structural drawings for the original structure indicate a design wind speed of 140 mph."<sup>15</sup> TT reports that after the Gregorian upgrade, "A&W confirmed the two speeds of 110 mph and 123 mph for the global and local design of the upgrade respectively and, to our knowledge, the final design was based on those wind speeds."<sup>16</sup> A summary of the available documentation is illustrated in Figure 2-2.<sup>17</sup>

FIGURE 2-2 Available documentation regarding wind speeds.

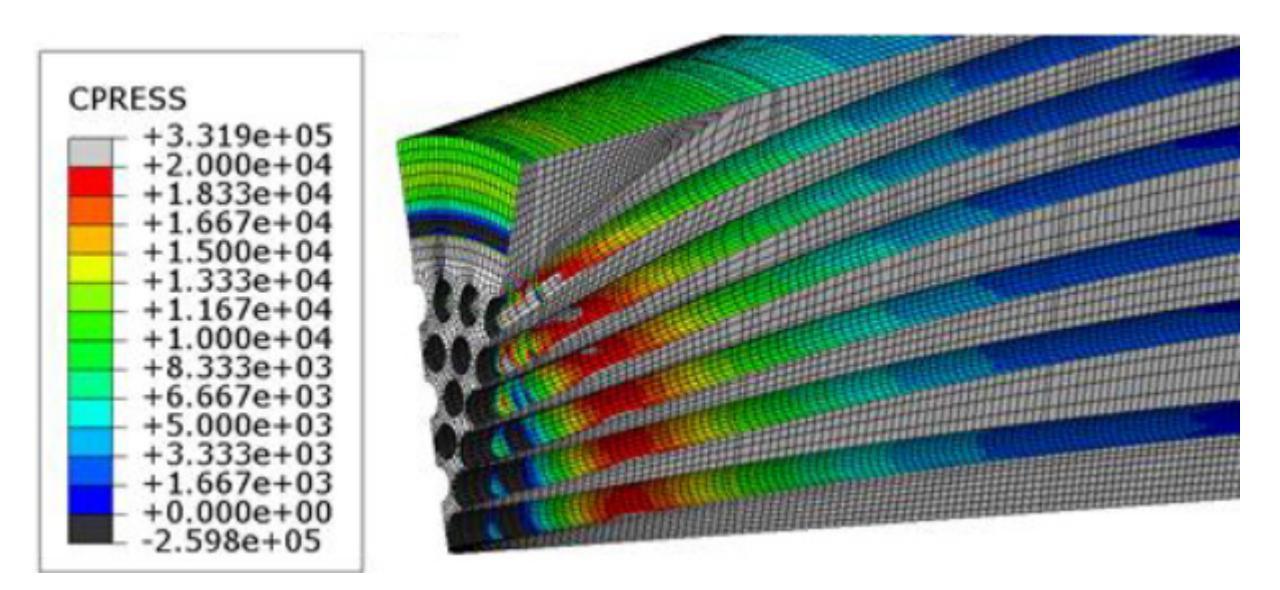
The finite element models presented in the NASA Engineering and Safety Center report<sup>11</sup> illustrate the detailed zinc behavior in the auxiliary cable's spelter socket. Figure 3-2 illustrates that the compressive stress pattern is a "spheroid" shape (red color).<sup>12</sup>

The compressive contact pressures form "arch actions" (compression struts) that transfer bond/shear forces developed between individual wires and zinc to the socket interior surface. The shear forces between the zinc and the wire are balanced by tension in the wires. Figure 3-2 shows various color bands (struts) representing different stress levels, with the red color signifying the arch with the highest compression. The arch stresses are highest near the mouth of the socket. These compressive forces (which correspond to transverse forces on the wires and the socket) produce shear (friction) resistance between the wire and the zinc in those areas. The compression stress at the socket is balanced by an equal and opposite force applied by the socket walls. The vertical components of these struts help resist the cable forces. The transverse arch action compression forces also contribute to the slanted (shear) wire failures observed on some outside wires in the M4N cable. Because of the higher stresses, the front of the socket is much more important than the back in resisting cable forces. This fact was also noted by Bradon and colleagues<sup>13</sup> in resin sockets.

**FIGURE 3-2** Finite element model of the auxiliary cable socket showing contact pressures (CPRESS) in pounds per square inch (psi).

The structural modeling and analyses of wire brooming issues presented in the TT Final Report were based on some assumptions.<sup>14</sup> The compression stress helps the socket resist cable forces by transferring (through compression in zinc) the inclined arch action forces to the socket's conical surface. If pullout were to occur due to excessive creep of zinc, then the compression stress shown in Figure 3-2 (e.g., the red band) would also dissipate, and the compressive force at the surface of the core would dissipate significantly. Creep (or flow) of zinc in shear will also be accompanied by the creep of zinc in compression, thus dissipating the force in the struts. Furthermore, the angle of the compression stress was assumed to be constant (i.e., equal to the longitudinal slope of the interior surface of the socket). It was not adjusted as a function of the radius of the core. Figure 3-2 shows that the slope of the compression stress changes at different r values.

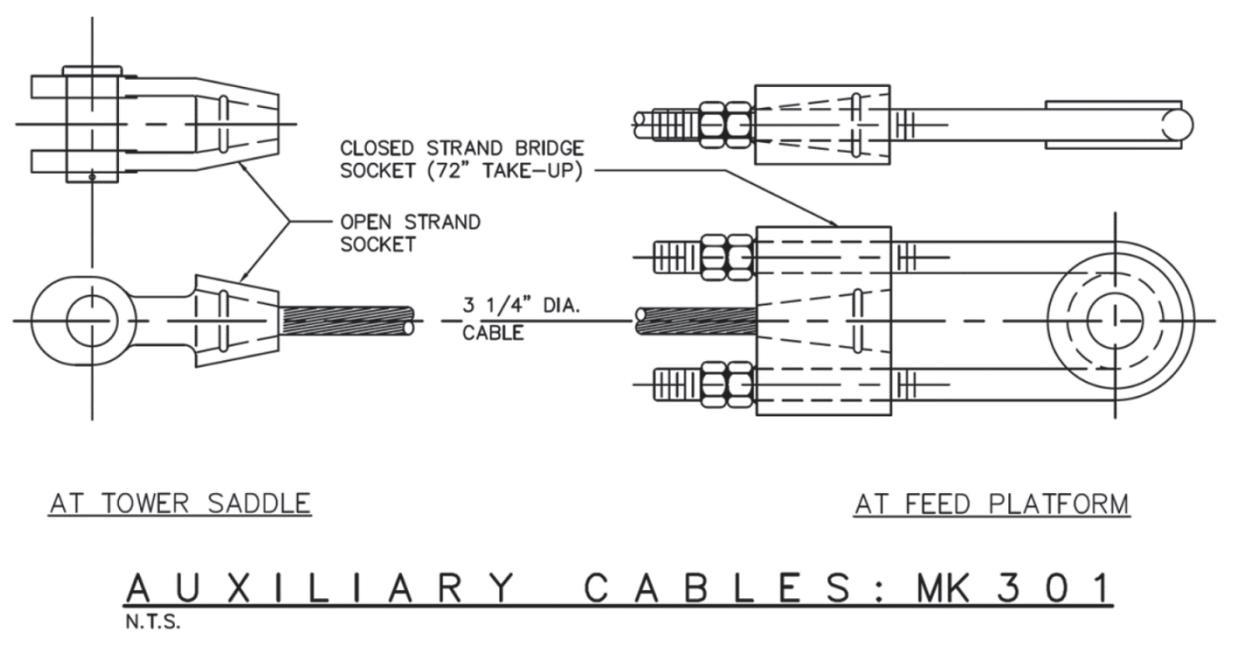
FIGURE 3-3 Auxiliary cable end socket geometry.

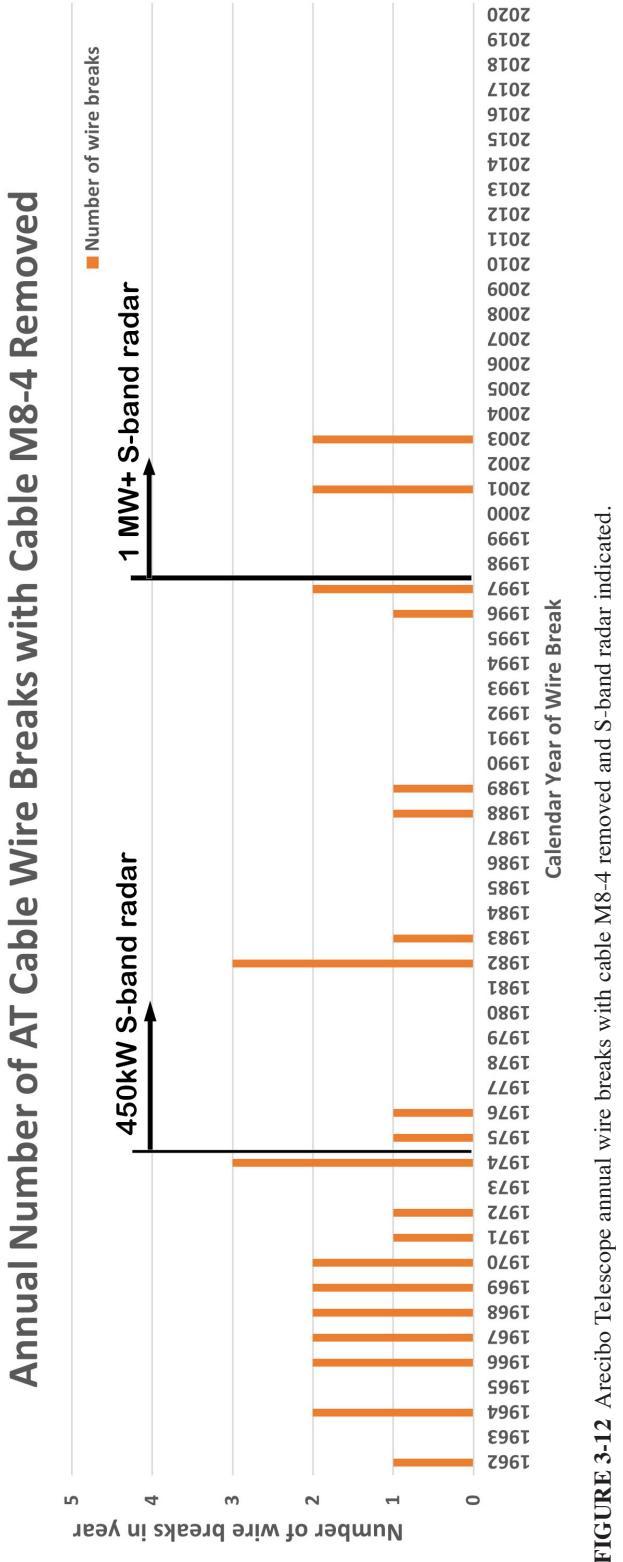
NOTE: Dry air sleeves were installed on the cables in 1972 and on the auxiliary cables in 1995.

wires were reported right up to the first cable failure. No wire breaks were reported in any Arecibo Telescope auxiliary cable,<sup>63</sup> although clamps were observed at the platform end of the M12 cables, the tower end of the M8N cable, and both ends of the M8S cable.<sup>64</sup> The M4N cable that failed first had no reported clamps or wire breaks. Ray Lugo, University of Central Florida, told the committee that he asked the WSP, WJE, and TT team, "So what is the standard? You know, can you have five wire breaks? Can you have 10? Whatever? And so, I was actually told that there is no standard."<sup>65</sup> The number of wire breaks was found to be unrelated to the load in the cable.
